**TUIRE & PAUL
PICKERING**
Mono Mills, Ontario

**DESIGN AND CONSTRUCTION
TEAM**

6-Stall Horse Barn & Manure Storage

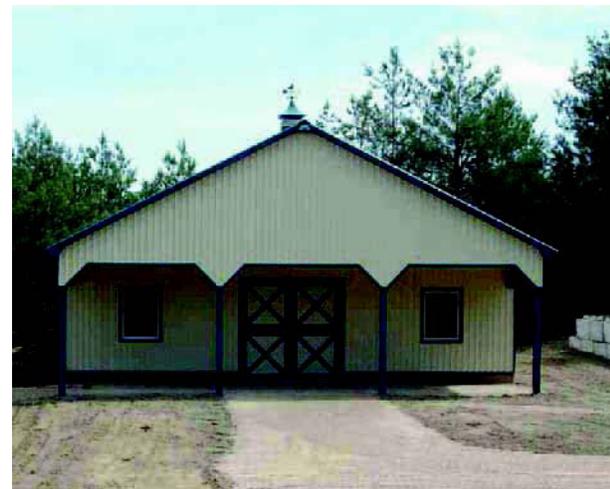
The barn roof is fairly high pitch (6/12) with 29 gauge Century Rib profile galvanized steel prepainted QC8330 Heron Blue. Trim is also Heron Blue. The walls are 29 gauge galvanized steel prepainted CQ8021 Beige in the Diamond Rib profile. The structure is a standard horse barn except for an 8' covered porch at the front to accommodate 'sitting out'. The porch has a cream ceiling and blue roof to match the rest of the exterior.

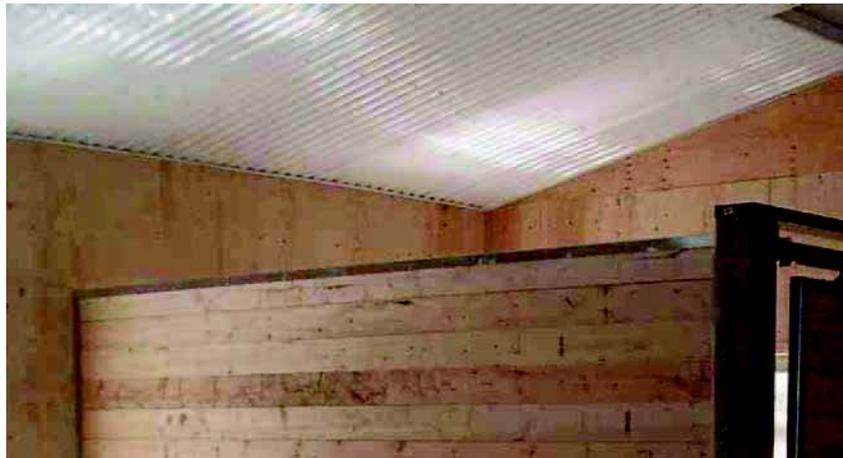
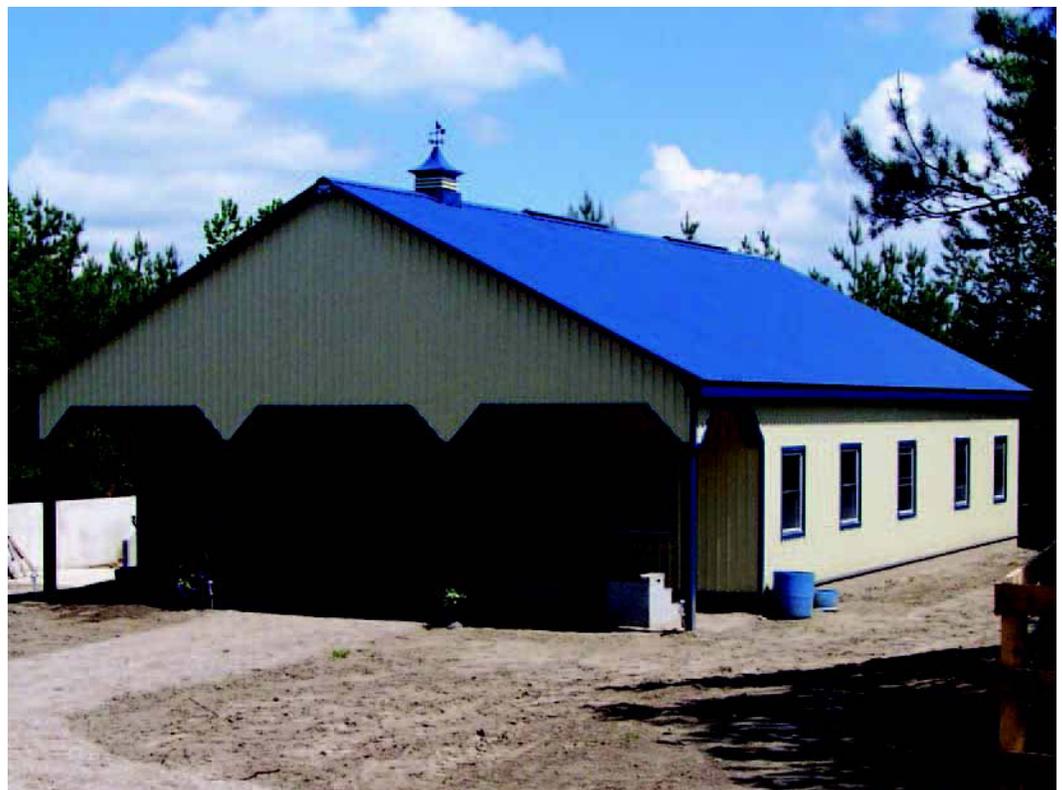
The six horse stalls are 10' x 12' with welded stall systems and grilled partitions all finished with 2x6 T&G spruce planking to 8'-0" high, with the remainder clad with select plywood. They have in floor hot water heating with ceramic floors covered with 3/4" thick rubber mats. Each stall has 36" x 48" double hung windows complete with grills. At the ends of the building

are 8' x 8' double Dutch doors. The barn floor, except for the stalls, is broom-finish concrete. The facility includes an insulated tack storage area. Completing the structure outside the barn is a 12' x 24' concrete manure storage with three 4' high walls and chamfered ends. To complement the facility is an Outdoor Sand Ring, Grand Prix Grass Ring and observation berm.

This being a high-moisture environment, ventilation is important. It is achieved here with roof vents and soft vents in the walls. Manually opened windows facilitate a crossbreeze. Walls and ceiling bear standard insulation and Super 6 vapour barrier. Moisture protection for the ceiling is achieved by means of a PVC liner panel attached to the purlins strapping the trusses.
